Manhole Inspection Summary

Manhole # S35AA1091MH

Location Address: **3501 CALVERT AVE** Cross Street: **UNIVERSITY PKWY**

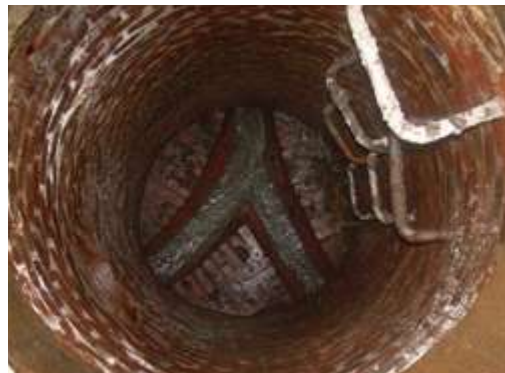
Top View

Corroded steps. Bench debris.

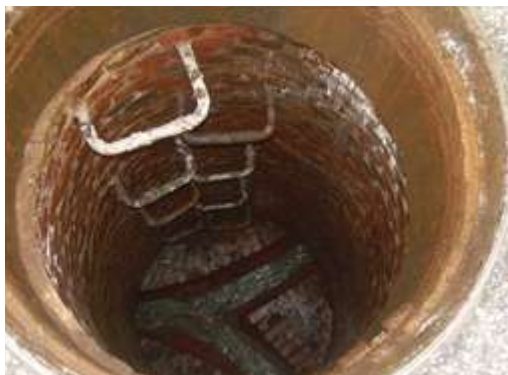
Defect

Frame leaks. Adjustment and Barrel infiltration - other side.

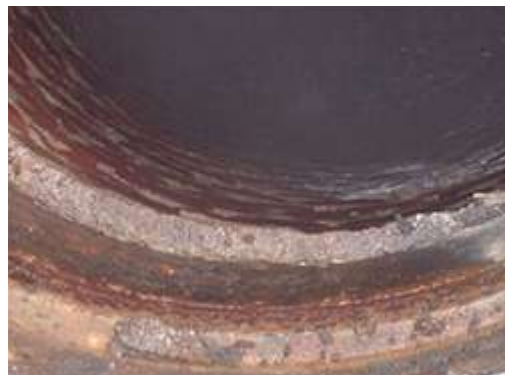
Defect

Frame leaks. Frame offset.

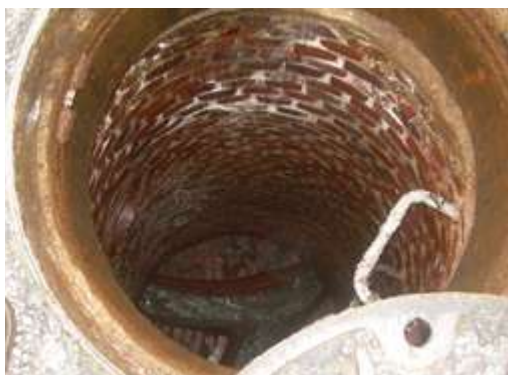
Defect

Frame leaks. Adjustment and Barrel infiltration.

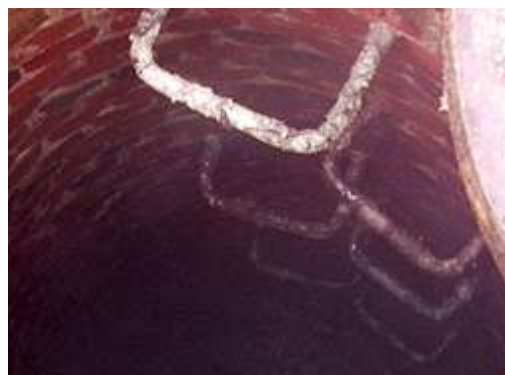
Defect

Corroded steps.

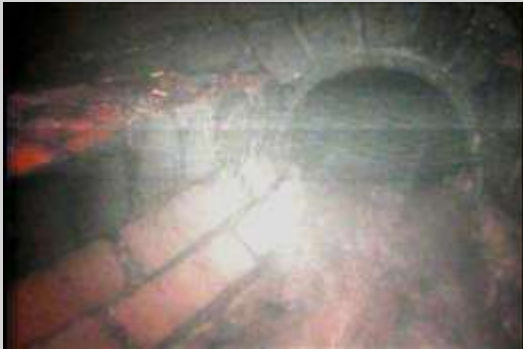
10 in. Circular Gravity Sewer Pipe Out @ 12 O'Clock

Infiltration: **None** Pipe Seal Cond: **Unknown**

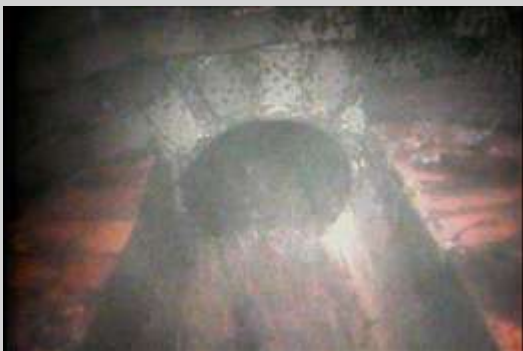
10 in. Circular Gravity Sewer Pipe In @ 5 O'Clock

Infiltration: **Evidence** Pipe Seal Cond: **Unknown**

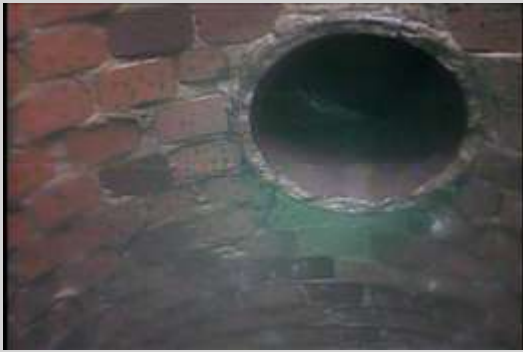
Pipe In @ 8 O'Clock

Infiltration: **Evidence** Pipe Seal Cond: **Unknown**

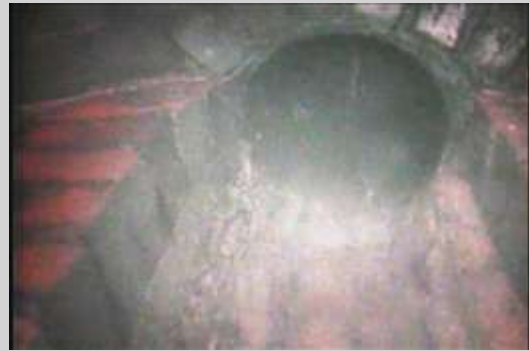
Drop In @ 8 O'Clock

Drop Condition: **Open**
